EB Developments Limited

GEOTECHNICAL SUITABILITY REPORT FOR PROPOSED SUBDIVISION

Tamure Place and Peter Snell Road, Ruakaka

Project Reference: 18319

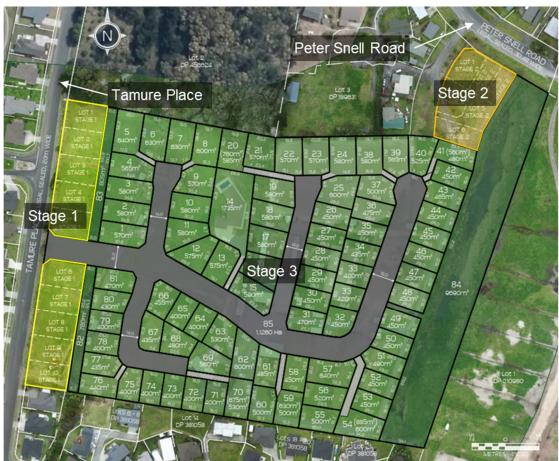
Figure 2: Proposed scheme plan. Modified from supplied Reyburn and Bryant C16471b Rev B.

The development will create approximately 81 residential lots generally in the range of $400 - 600m^2$, along with several drainage reserves and vested road reserves. The proposed scheme plan is shown in Figure 2 below and attached as Appendix A. It is expected that the scheme plan will be refined prior to submission for resource consent, however the overall layout is expected to be broadly similar.

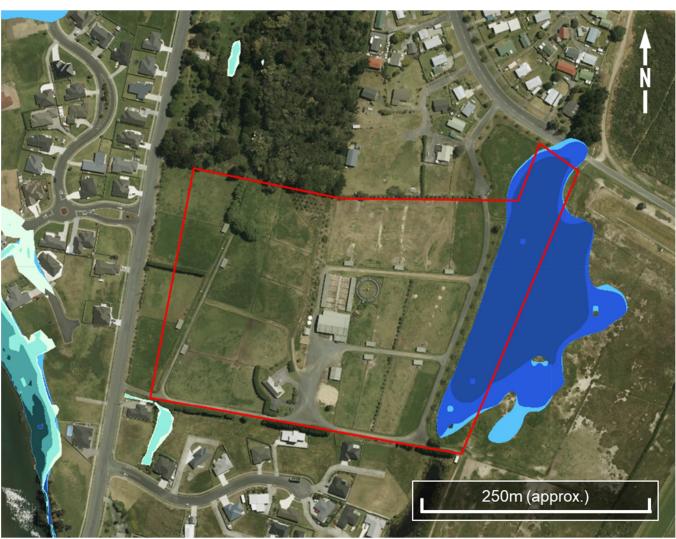
Figure 3: NRC Mapped flood susceptibility of the proposed subdivision

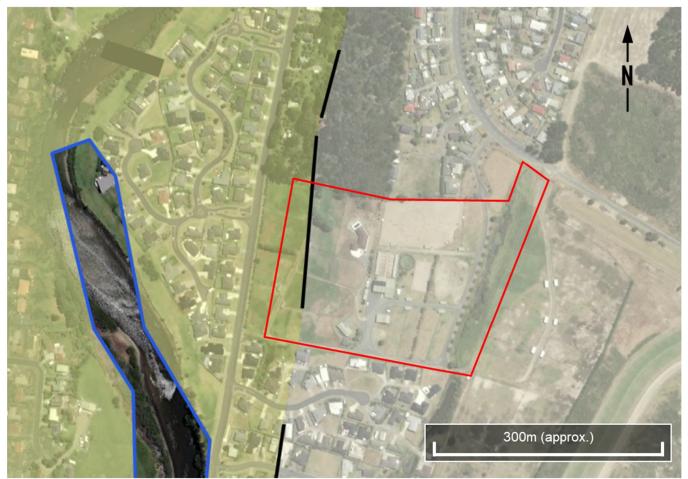
Figure 4: GNS mapped lithologies beneath the site. The dotted line is indicative on an inferred boundary between the units.

The 1:250,000 geological map of the region⁴ (Figure 4) shows the site as being underlain by Holocene windblown deposits across most of the site with this unit extending east towards the coast. Late Pleistocene stable dune deposits are mapped along the western margins of the site, extending west to the Ruakaka River and beyond. Descriptions of these materials are found in Table 1 below.

Key name (shaded to Figure 4)	GNS Description	GNS absolute age (years)	Inferred age
OIS1 (Holocene) parabolic dunes	Loose to poorly consolidated sand in fixed parabolic and local transverse dunes; minor sand, mud and peat in interdune deposits.	0 – 14,000	5,000
OIS5 (Late Pleistocene) stable dune deposits	Weakly cemented sand in fixed transverse dune ridges.	71,000 – 128,000	115,000

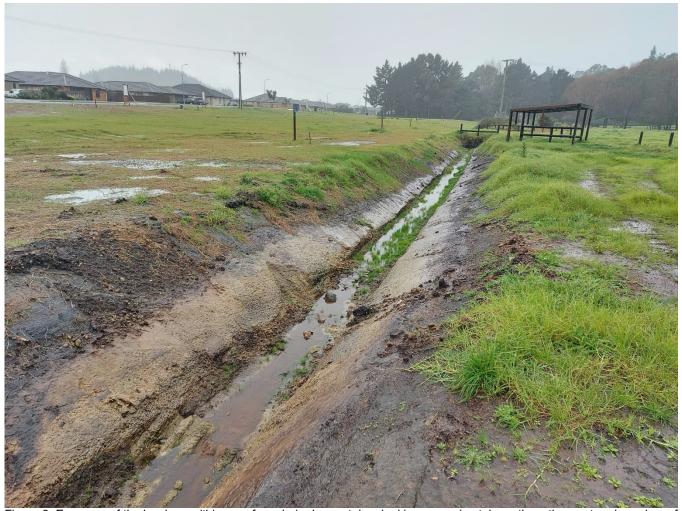
Figure 6: Exposure of the hardpan within a surface drain. Image taken looking approximately north on the western boundary of Lot 78.

Hand augers encountered a thin veneer of topsoil and loose to medium dense sand, underlain at shallow depth (0.4 to 0.8m) by a 'hardpan' of very dense cemented sand, leading to shallow auger refusal. Scala penetrometer testing refused immediately on the hardpan.

- The western low-lying area is underlain by Pleistocene age dune sands with a podsolised 'hardpan' at shallow depth, and generally dense sands below.
- The central ridge is underlain by variable loose to medium dense dune sands. This is inferred to be the
 western boundary of the recent Holocene dune sands, pushed up into a high ridge as sea-levels began
 to fall from their recent maximum. Pleistocene dune sands appear to slope towards the east beneath
 these deposits.
- The eastern low-lying area is underlain by Holocene dune sand, which appears to have been relevelled
 to form paddocks. This comprises predominantly medium dense sand with some lenses of lower density
 or organic material. The sands generally increase in density with depth. The Pleistocene age dunes

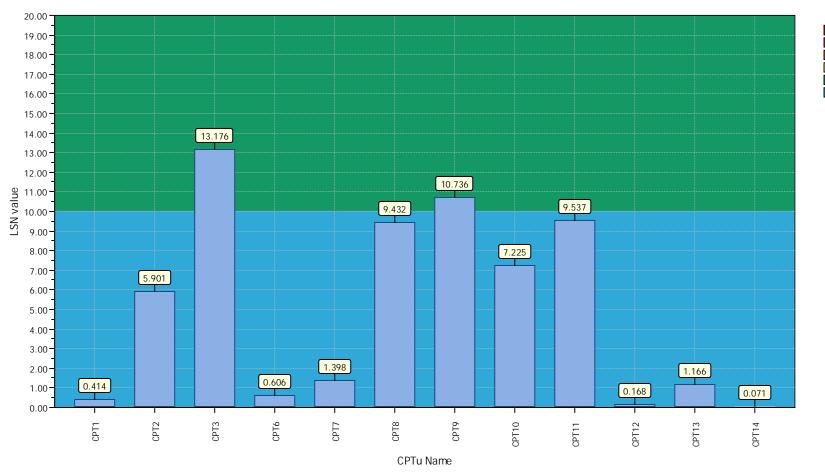
Overall Liquefaction Severity Number report

LSN color scheme

Severe damage

As expected, significant liquefaction was limited to CPTs on the eastern side of the site, and was only predicted for those CPTs which reached target depth (CPT08 to CPT11). CPT12 – CPT14 are expected to be underlain by similar ground conditions but had shallow refusal.

Liquefaction induced settlements became significant only in the 'lower bound' ULS event. At both the conventional (i.e. hazard based) ULS and SLS event no liquefaction is predicted.
